ALL WAGNER ROOFING RESTORES HANDS FIVE ROOF SYSTEMS ON ON THE U.S. NAVAL ACADEMY'S ROOF MAHAN HALL DECK BY CHRYSTINE ELLE HANUS

Project name: U.S. Naval Academy's Mahan Hall

Project location: Annapolis, Md.

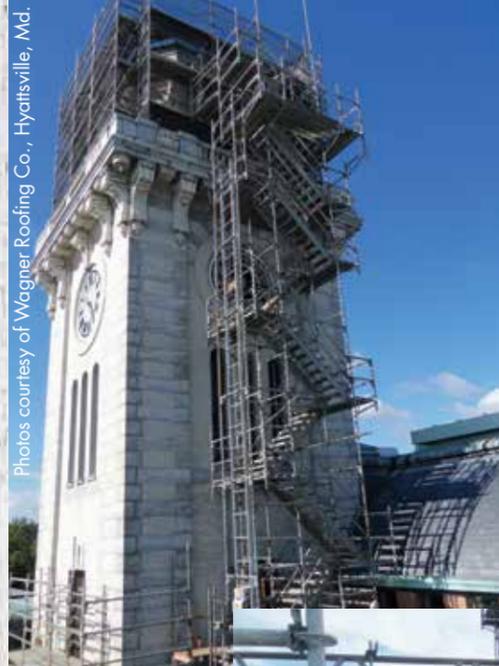
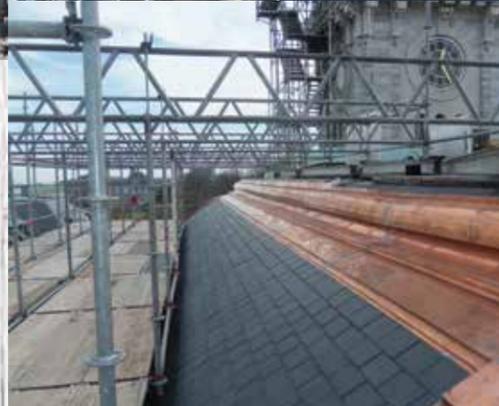
Top to bottom: A stair tower was installed for access and egress; new decorative copper flashing at the intersection of the slate mansard and flat-seam copper roofs

Per NAVFAC Engineering Manual 385, a stair tower also was installed for access and egress and strategically set where it could be reached in either direction but not farther than 75 feet from the farthest point of other access and egress points.

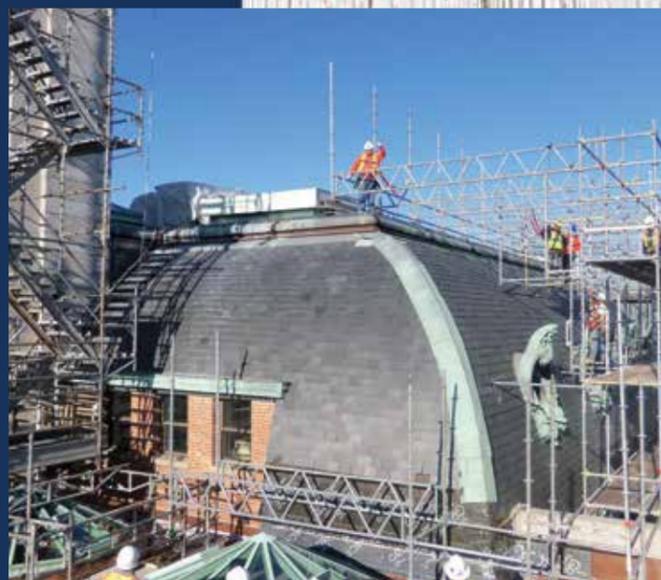
View of multiple roofs and details, including mansard slate, suspended scaffolding, hip metal and dormers

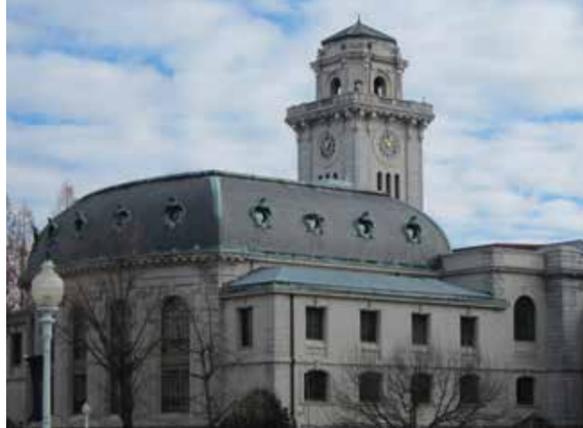
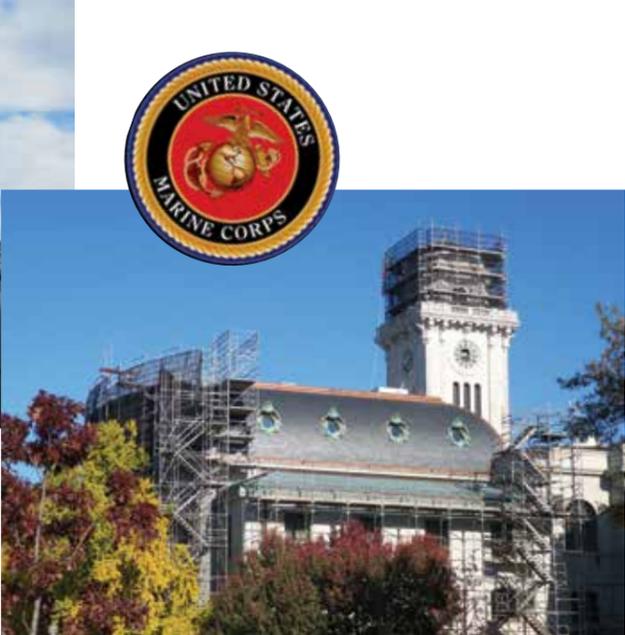
Left to right: Mahan Hall's southwest elevation before replacement; Mahan Hall and the clock tower under construction

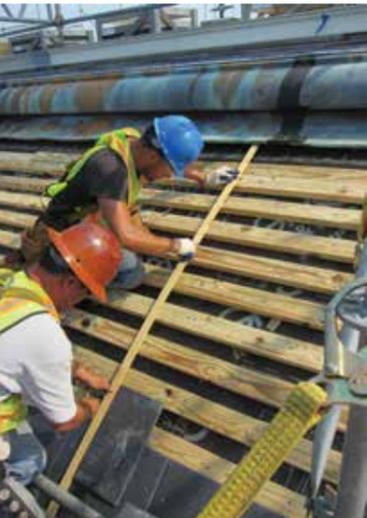
Slate on the mansard roof was installed onto wood nailers, which were preplanned and laid out so the nail holes for the slate aligned with a nailer.

The mansard roof system installation was quite different. The slate was installed directly onto wood nailers, which were preplanned and laid out so the nail holes for the slate aligned with a nailer.

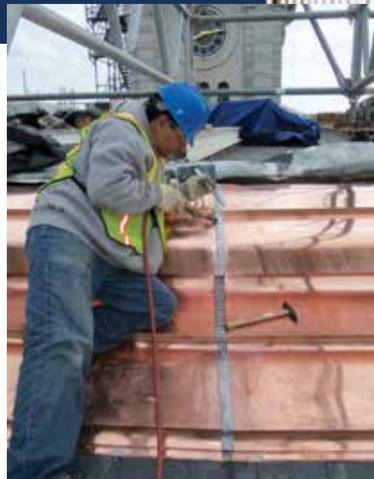
New copper cornice being installed

Once the slate and dormers were installed, Wagner Roofing's sheet metal department fabricated and installed the 20-ounce copper radial hip cap and two-piece bull-nose transition cornice/apron along the top of the mansard. Both details were duplicated to exact dimensions but were installed using a more secure hidden-cleat method than originally had been used.

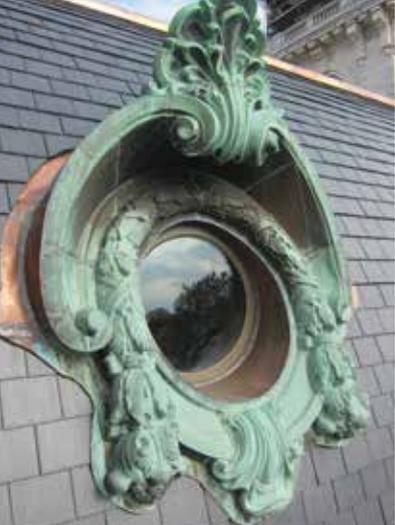
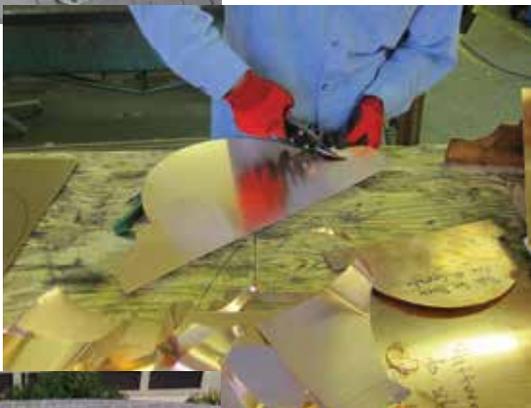
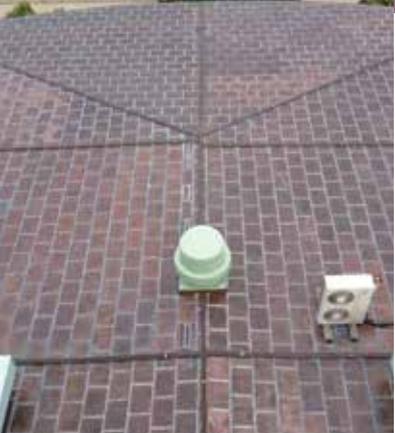
The 13 ornamental porthole dormers took five workers each to remove and reinstall. In many places, the copper had worn through and most of the soldered seams had either split or cracked from weather and wear during the past 104 years. The dormers were handled carefully so they would not be further damaged.

Top to bottom: Each dormer took about 120 man-hours to remove, repair and install; copper details were fabricated in Wagner Roofing's metal shop; the completed flat-seam copper roof system above the mansard.

decided to replace the circular copper window tubes and upper crickets with new 20-ounce copper and reline the backs of the dormers' ornamental façades with new 20-ounce copper because these dormer parts were the least visible from the ground and would patina quickly. Each dormer took about 120 man-hours
